## **Merkel & Associates, Inc.**

March 10, 2008  
M&A #06-049-06

### **Re: Debris removal at the San Diego Unified Port District's A-8 Anchorage**

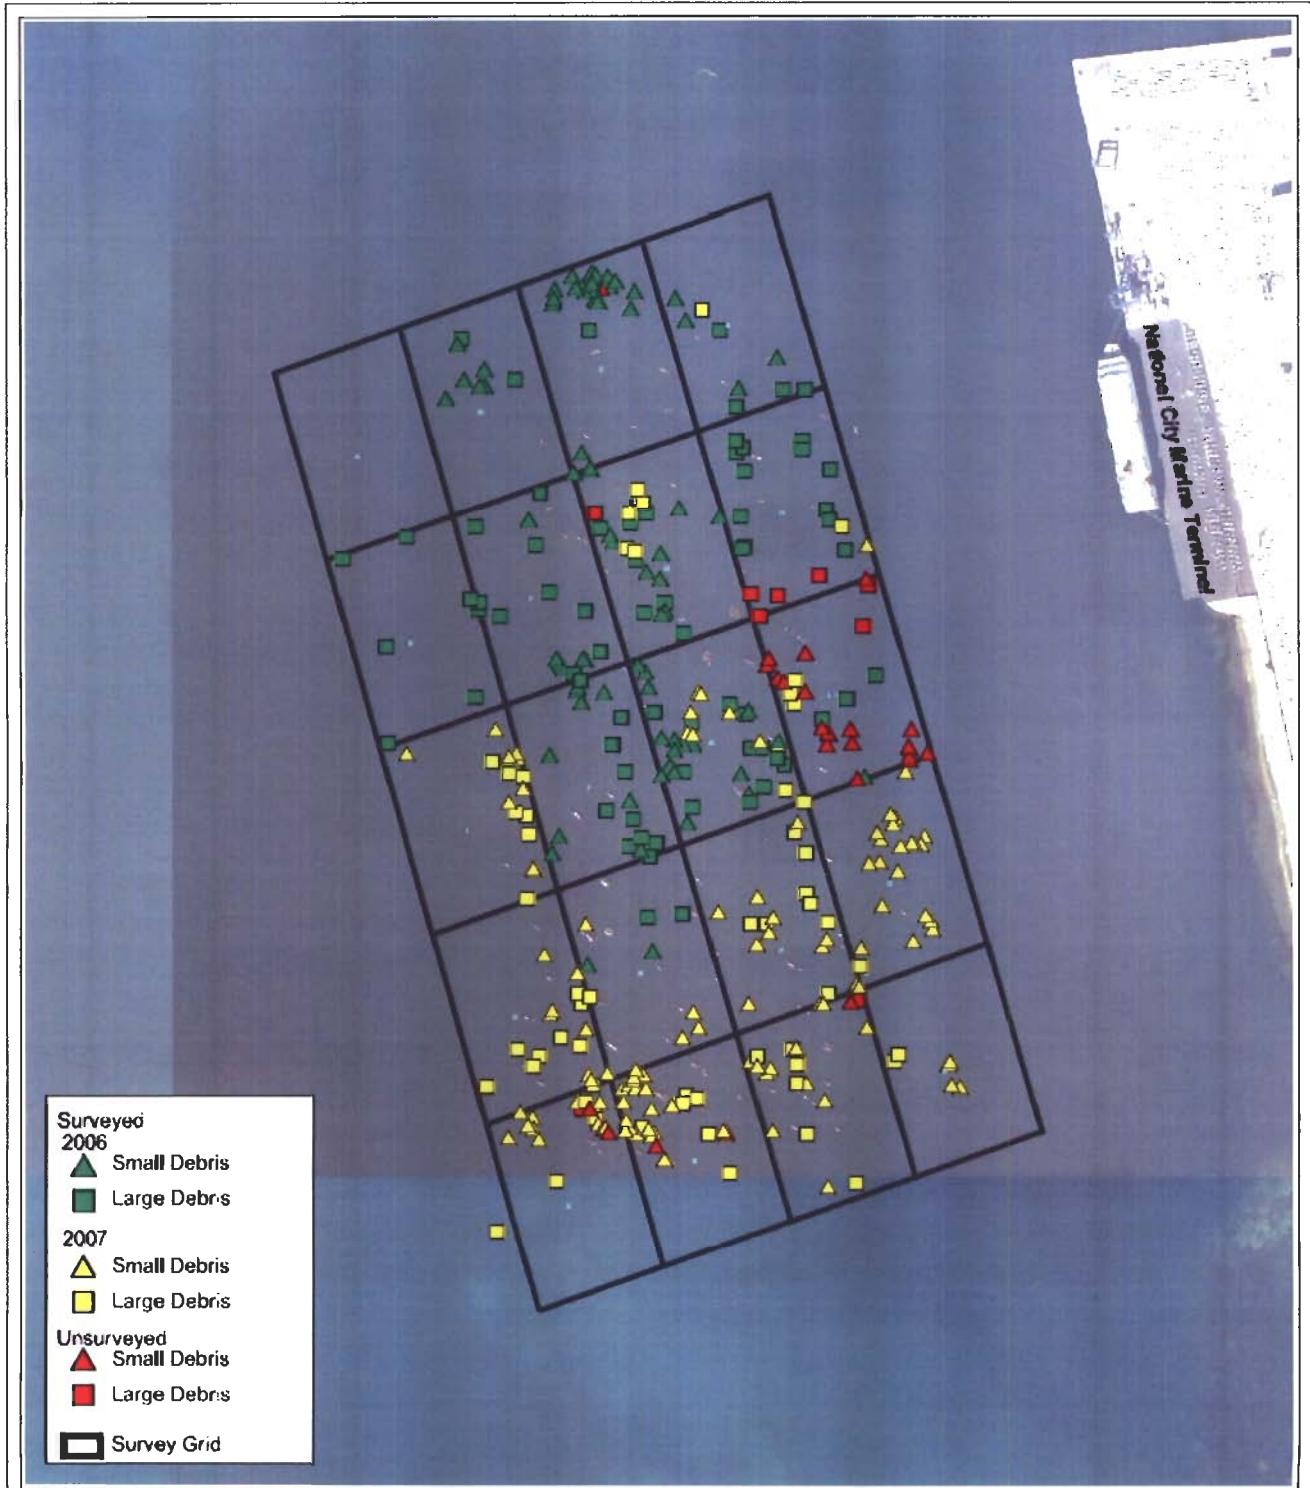
**Figure 2**

**Clean-up Status Map**  
San Diego Unified Port District  
A-8 Anchorage Debris Removal Project

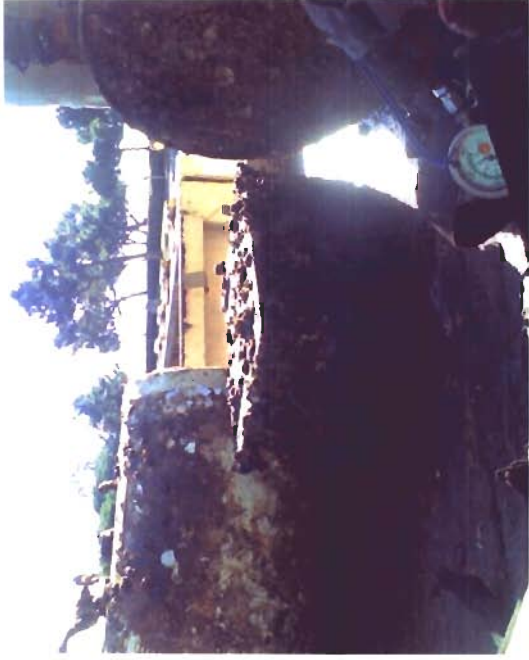
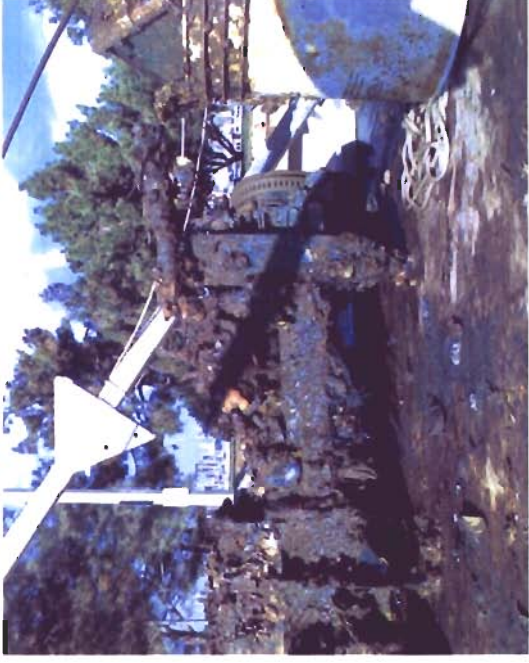
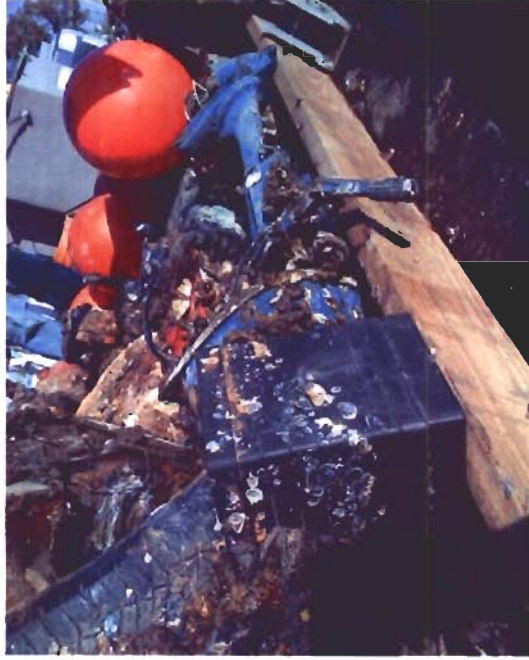
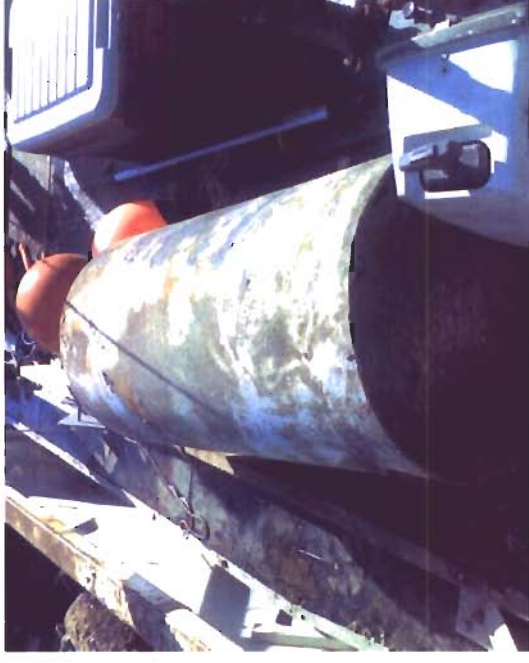
Photo Page 1. Environmental debris items recovered from the A-8 Anchorage in December 2007, large marine battery (upper left), outboard engine (upper right), miscellaneous debris including an outboard engine and battery (lower left), tank with unknown contents (lower right).

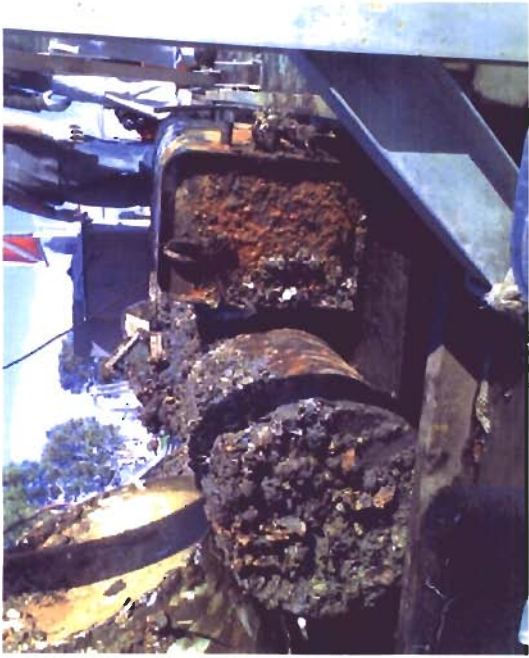
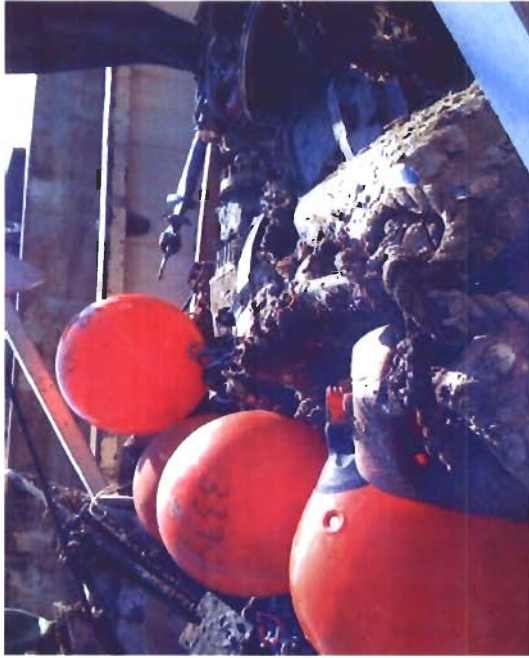
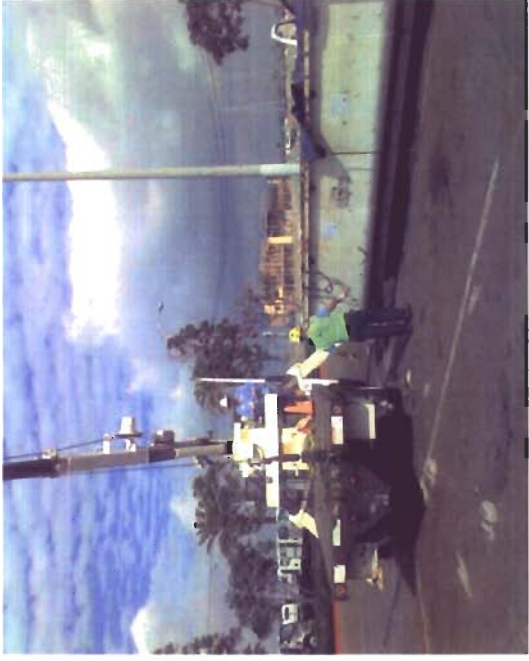
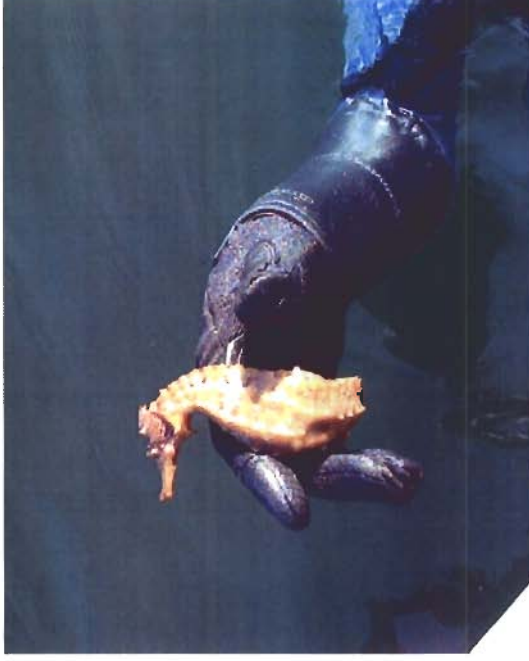
Photo Page 2. Photos taken during environmental debris removal from the A-8 Anchorage in December 2007, miscellaneous tanks with unknown contents (upper left), Port of San Diego staff transferring debris items into the temporary holding container (upper right), miscellaneous debris items including fuel cans, a battery, and small engine (*Hippocampus ingens*) being returned to the water, lower right.
