July 26, 2006

**PHASE II  
SUBSURFACE INVESTIGATION**

955 Harbor Island Drive  
San Diego, California 92101

AEI Project Number 29319

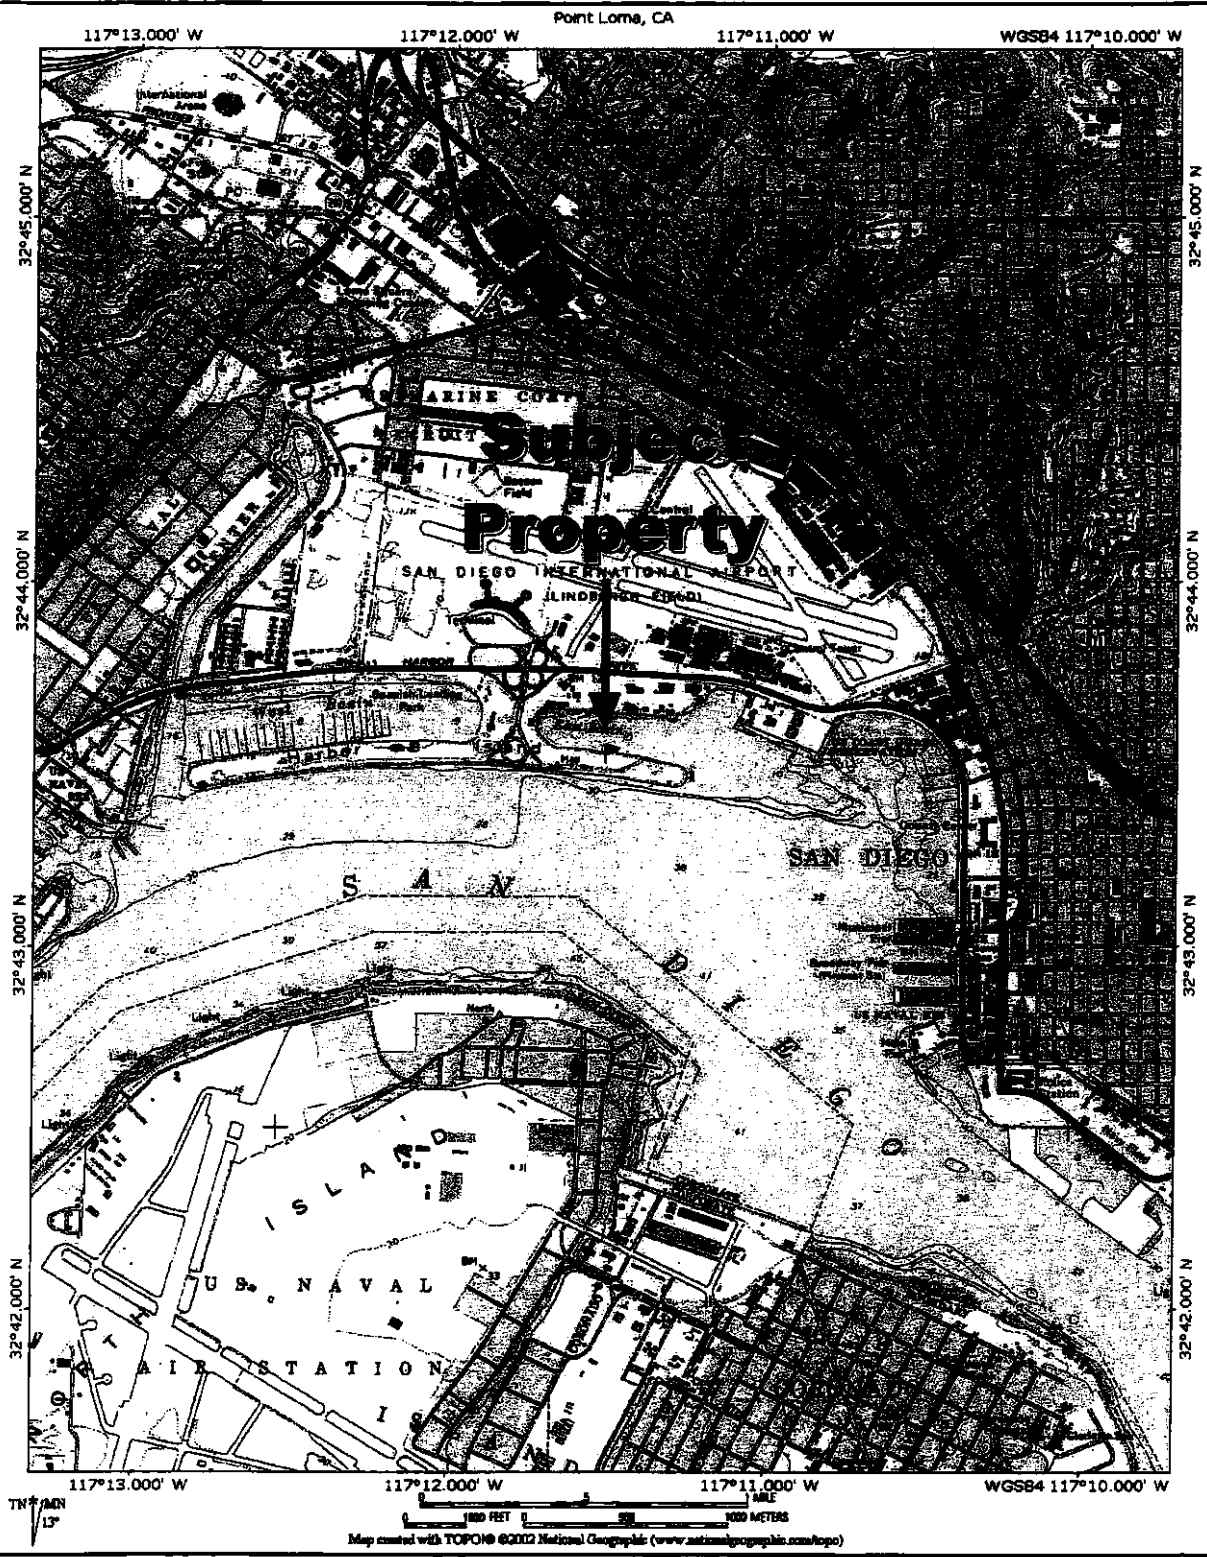
<b>AEI CONSULTANTS</b>	
2447 Pacific Coast Highway, Suite 101, Hermosa Beach, CA	
<b>SITE LOCATION MAP</b>	
955 Harbor Island Drive San Diego, California 92101	<b>FIGURE 1</b> Job No: 29319

USGS TOPOGRAPHIC MAP  
 POINT LOMA QUADRANGLE  
 Created 1967, Revised 1994
