14 September 2010
AMEC Project No. 9151000900.0001

**Re: Marina Trash Skimmer Monitoring
4th Quarterly Report – July 2010 – August 2010
San Diego, California**

Port of San Diego
Marina Trash Skimmer Monitoring
4th Quarterly Report – July 2010 – August 2010
AMEC Project No. 9151000900
14 September 2010

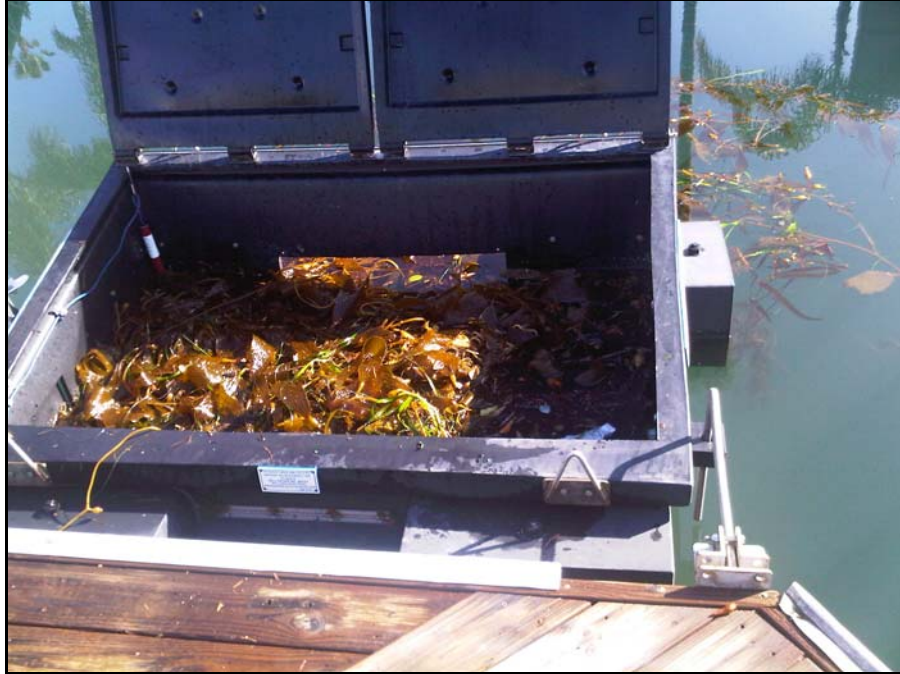
Photograph No. 1

glass bottles (Photograph No. 1). There were 4 occasions when a sheen was observed at this site, and the bilge pad was changed 8 times. The presence of greater quantities of anthropogenic marine debris is likely due to the nearby concert venue.

Half Moon Marina - Trash Skimmer

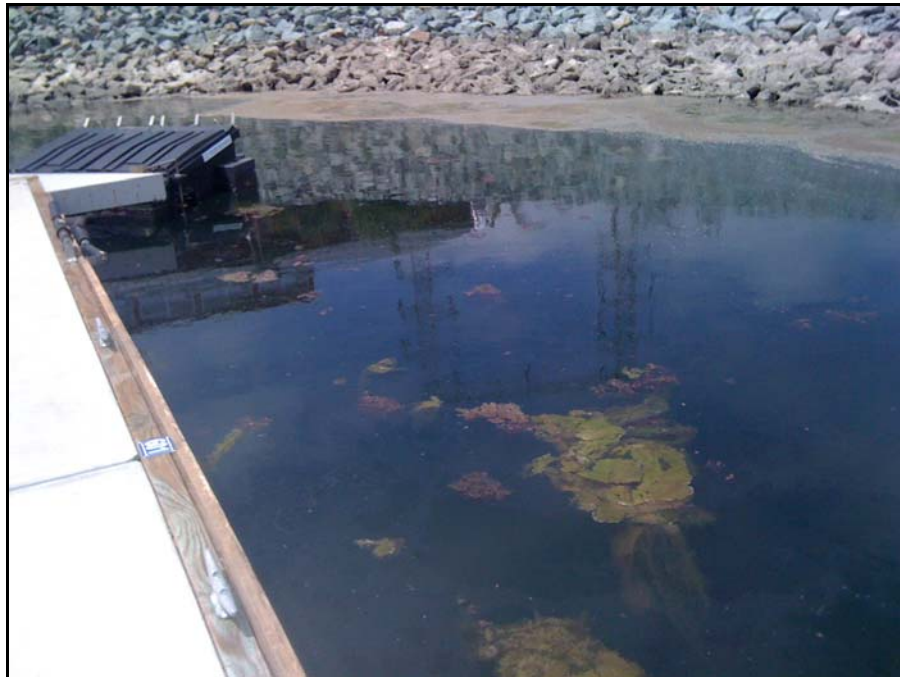
Examples of before and after trash skimmer operation at Pier 32 Marina are shown in Photograph No. 2 and Photograph No. 3.

Pier 32 Marina Trash Skimmer Area – Before Operation

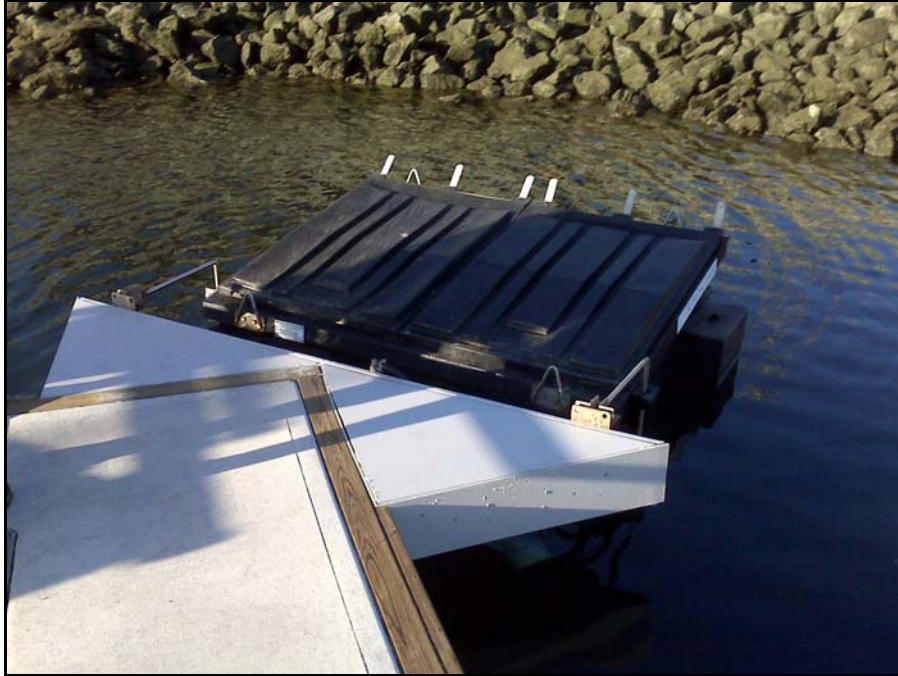
Photograph No. 3

Pier 32 Marina Trash Skimmer – After Operation

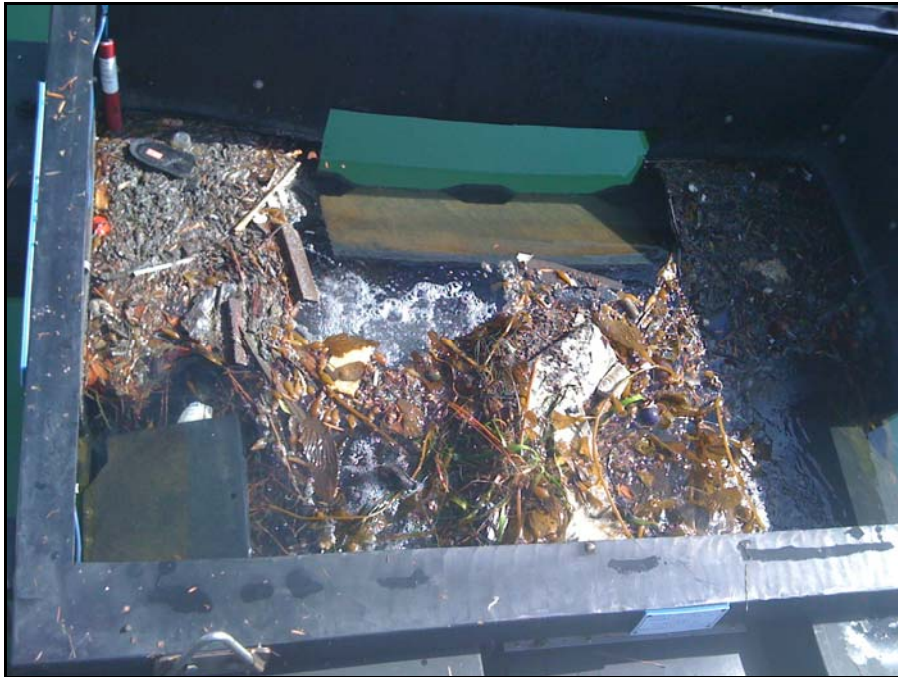
Photograph No. 4

Photographs No. 4 – 7 show various types of debris collected throughout the course of this project. Because of the placement of these Trash Skimmers, this debris was successfully removed from San Diego Bay.

Debris Collected by Trash Skimmer

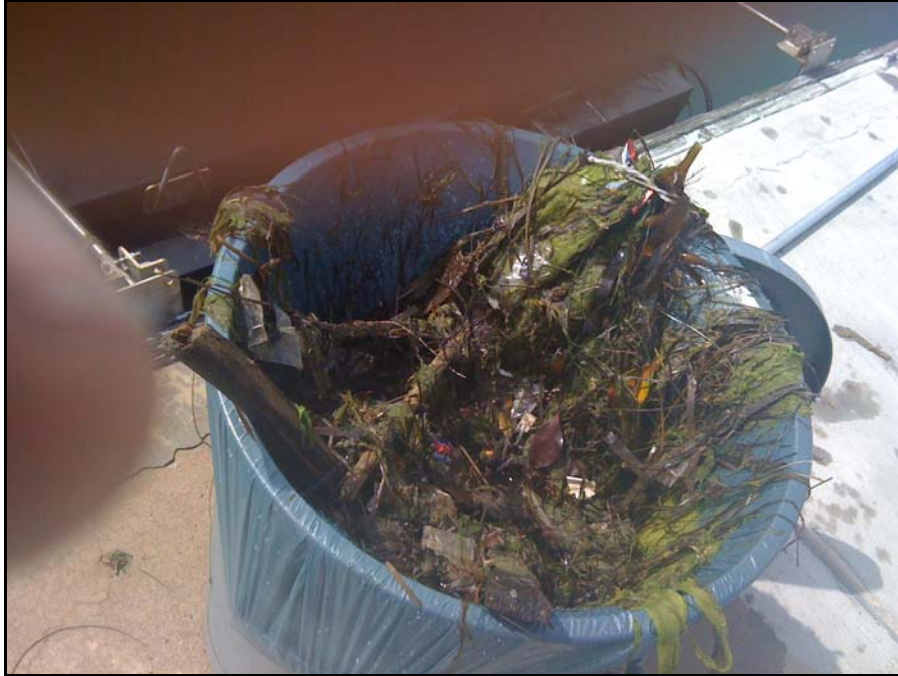
Photograph No. 5

Debris Collected by Trash Skimmer

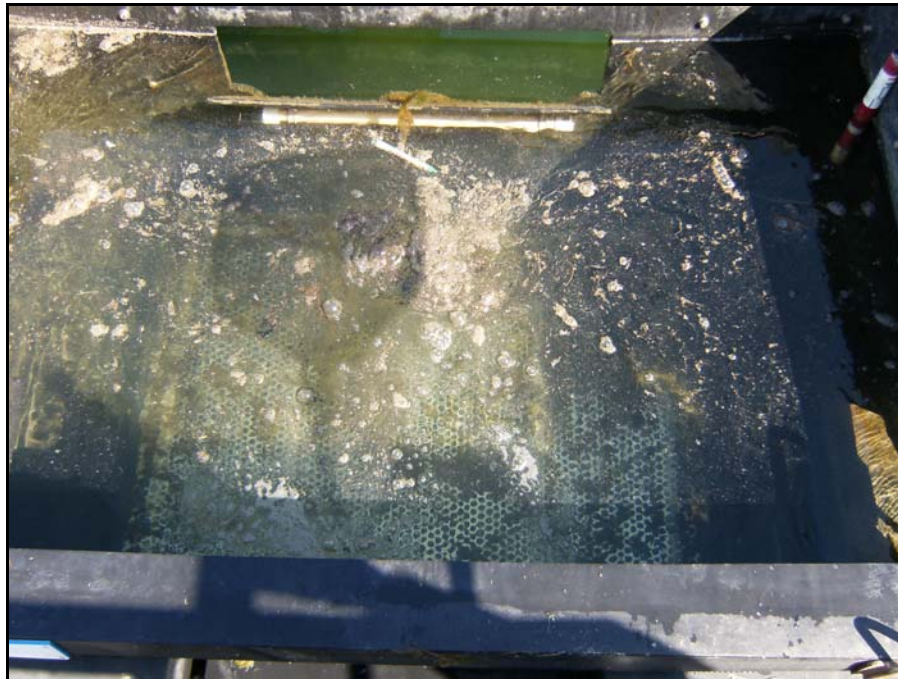
Photograph No. 6

Debris Collected by Trash Skimmer

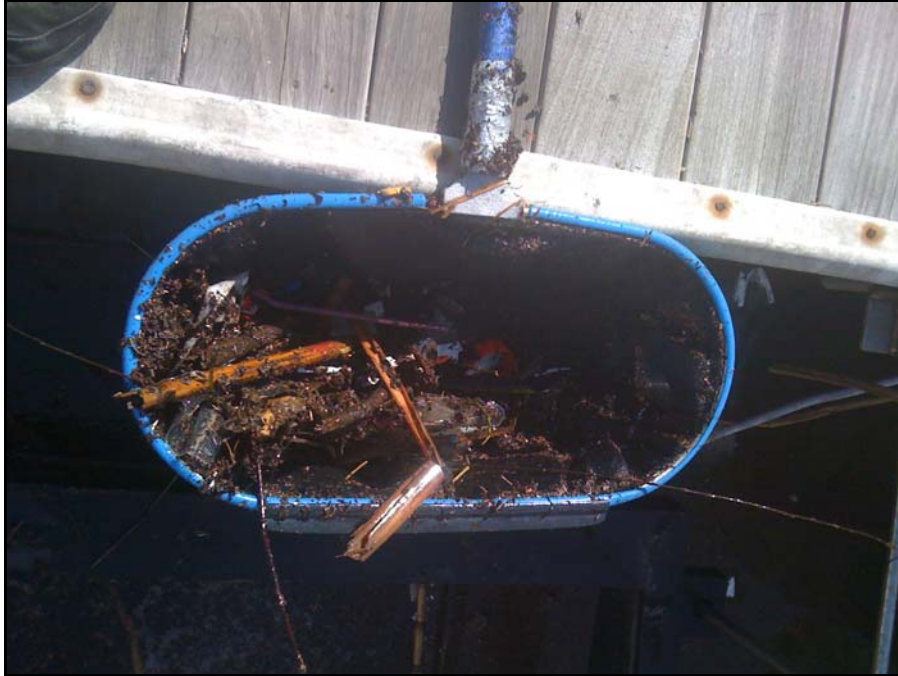
Photograph No. 7

Debris Collected by Trash Skimmer

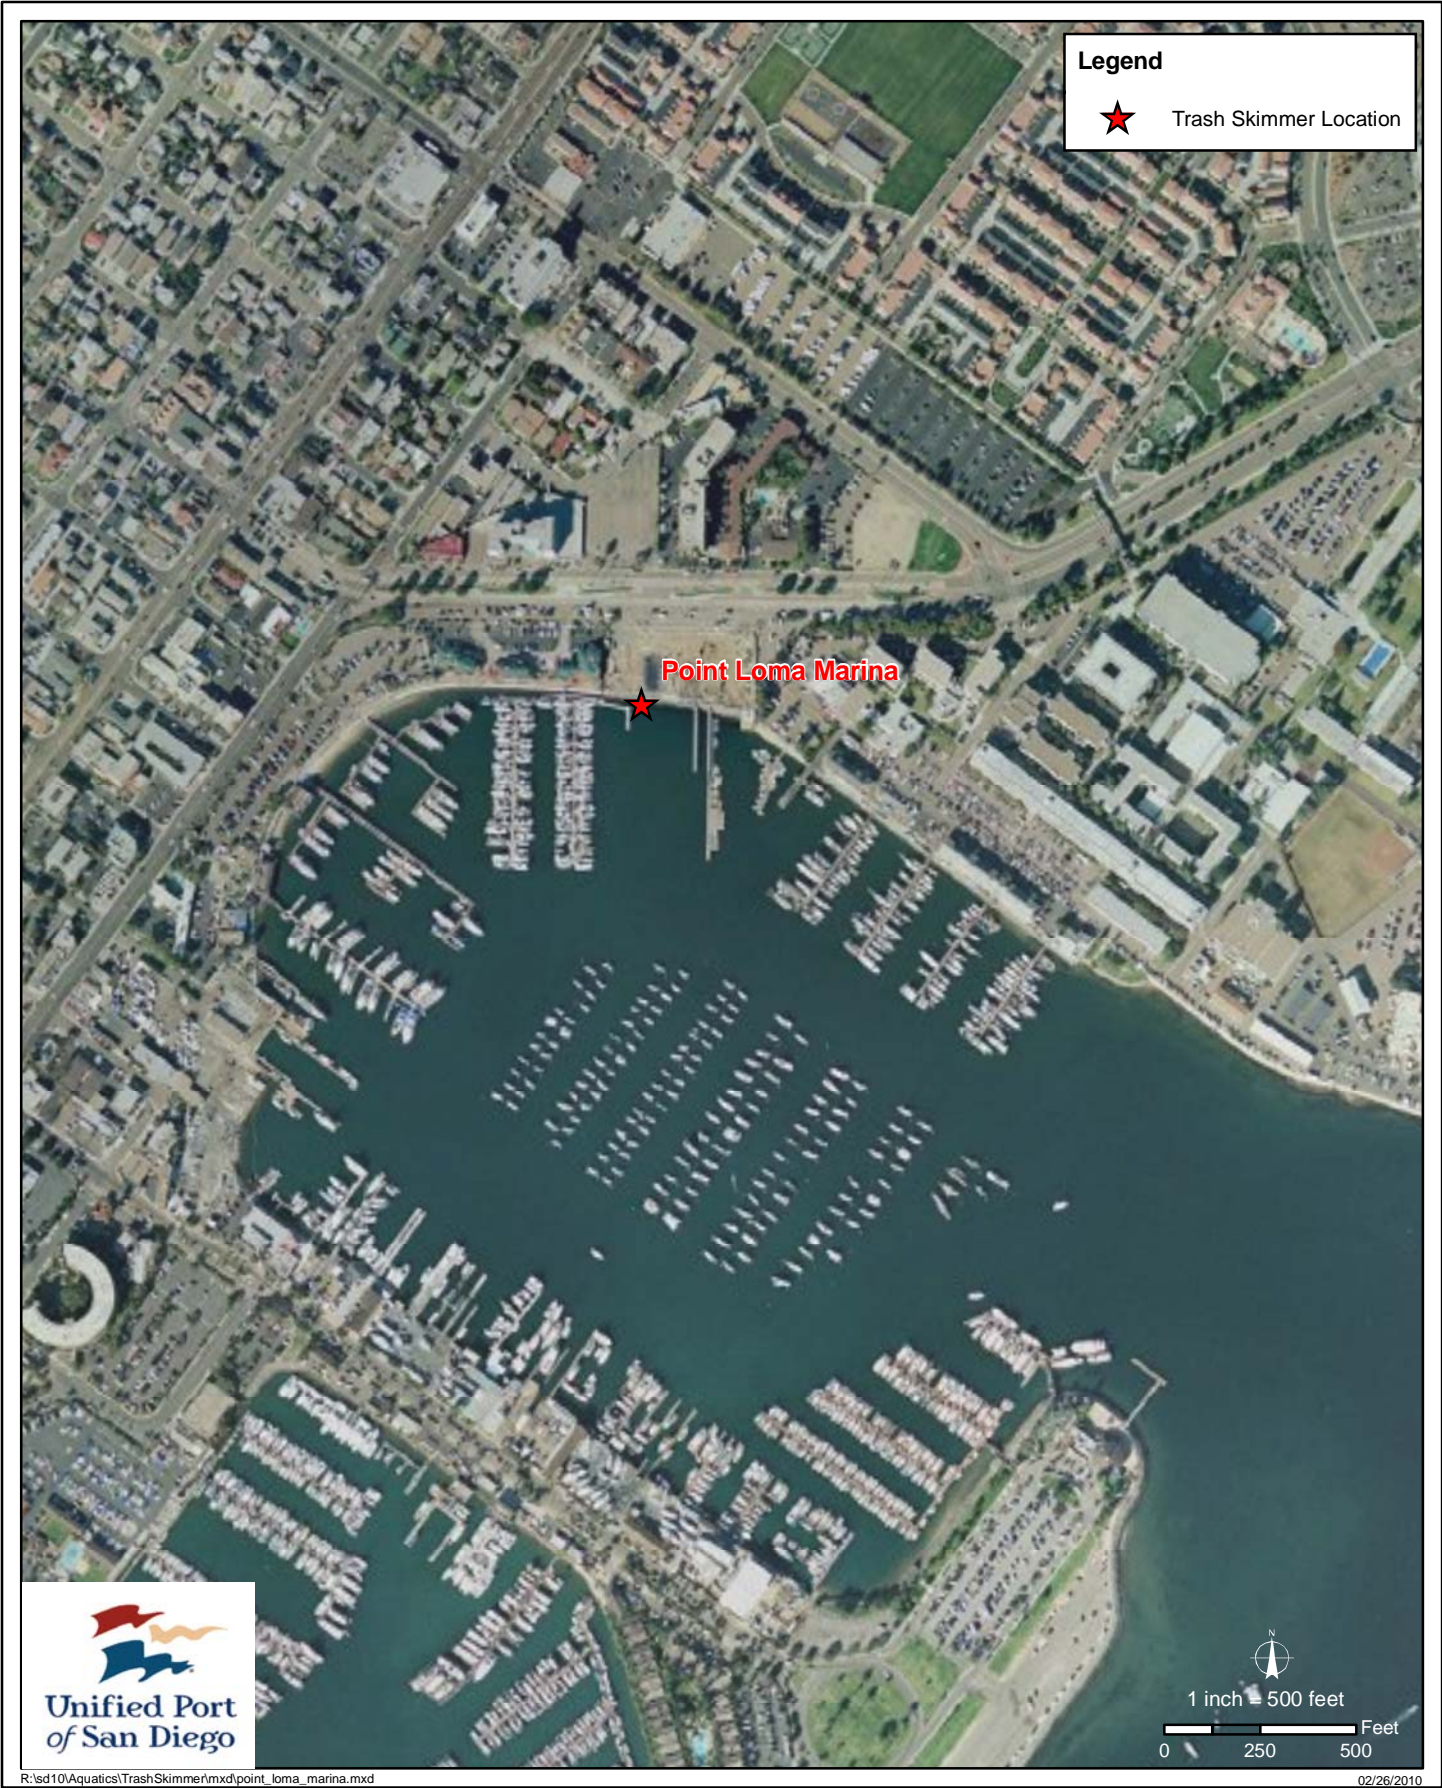
FIGURE
3

The trash skimmer at the Point Loma Marina is installed along the east side of the main dock located in the northeast corner of America's Cup Harbor, an area that tends to collect debris via prevailing winds and current circulation (Figure 3). An elevated public walkway with shops, restaurants and businesses overlooks this area.

Point Loma Marina
Trash Skimmer Location

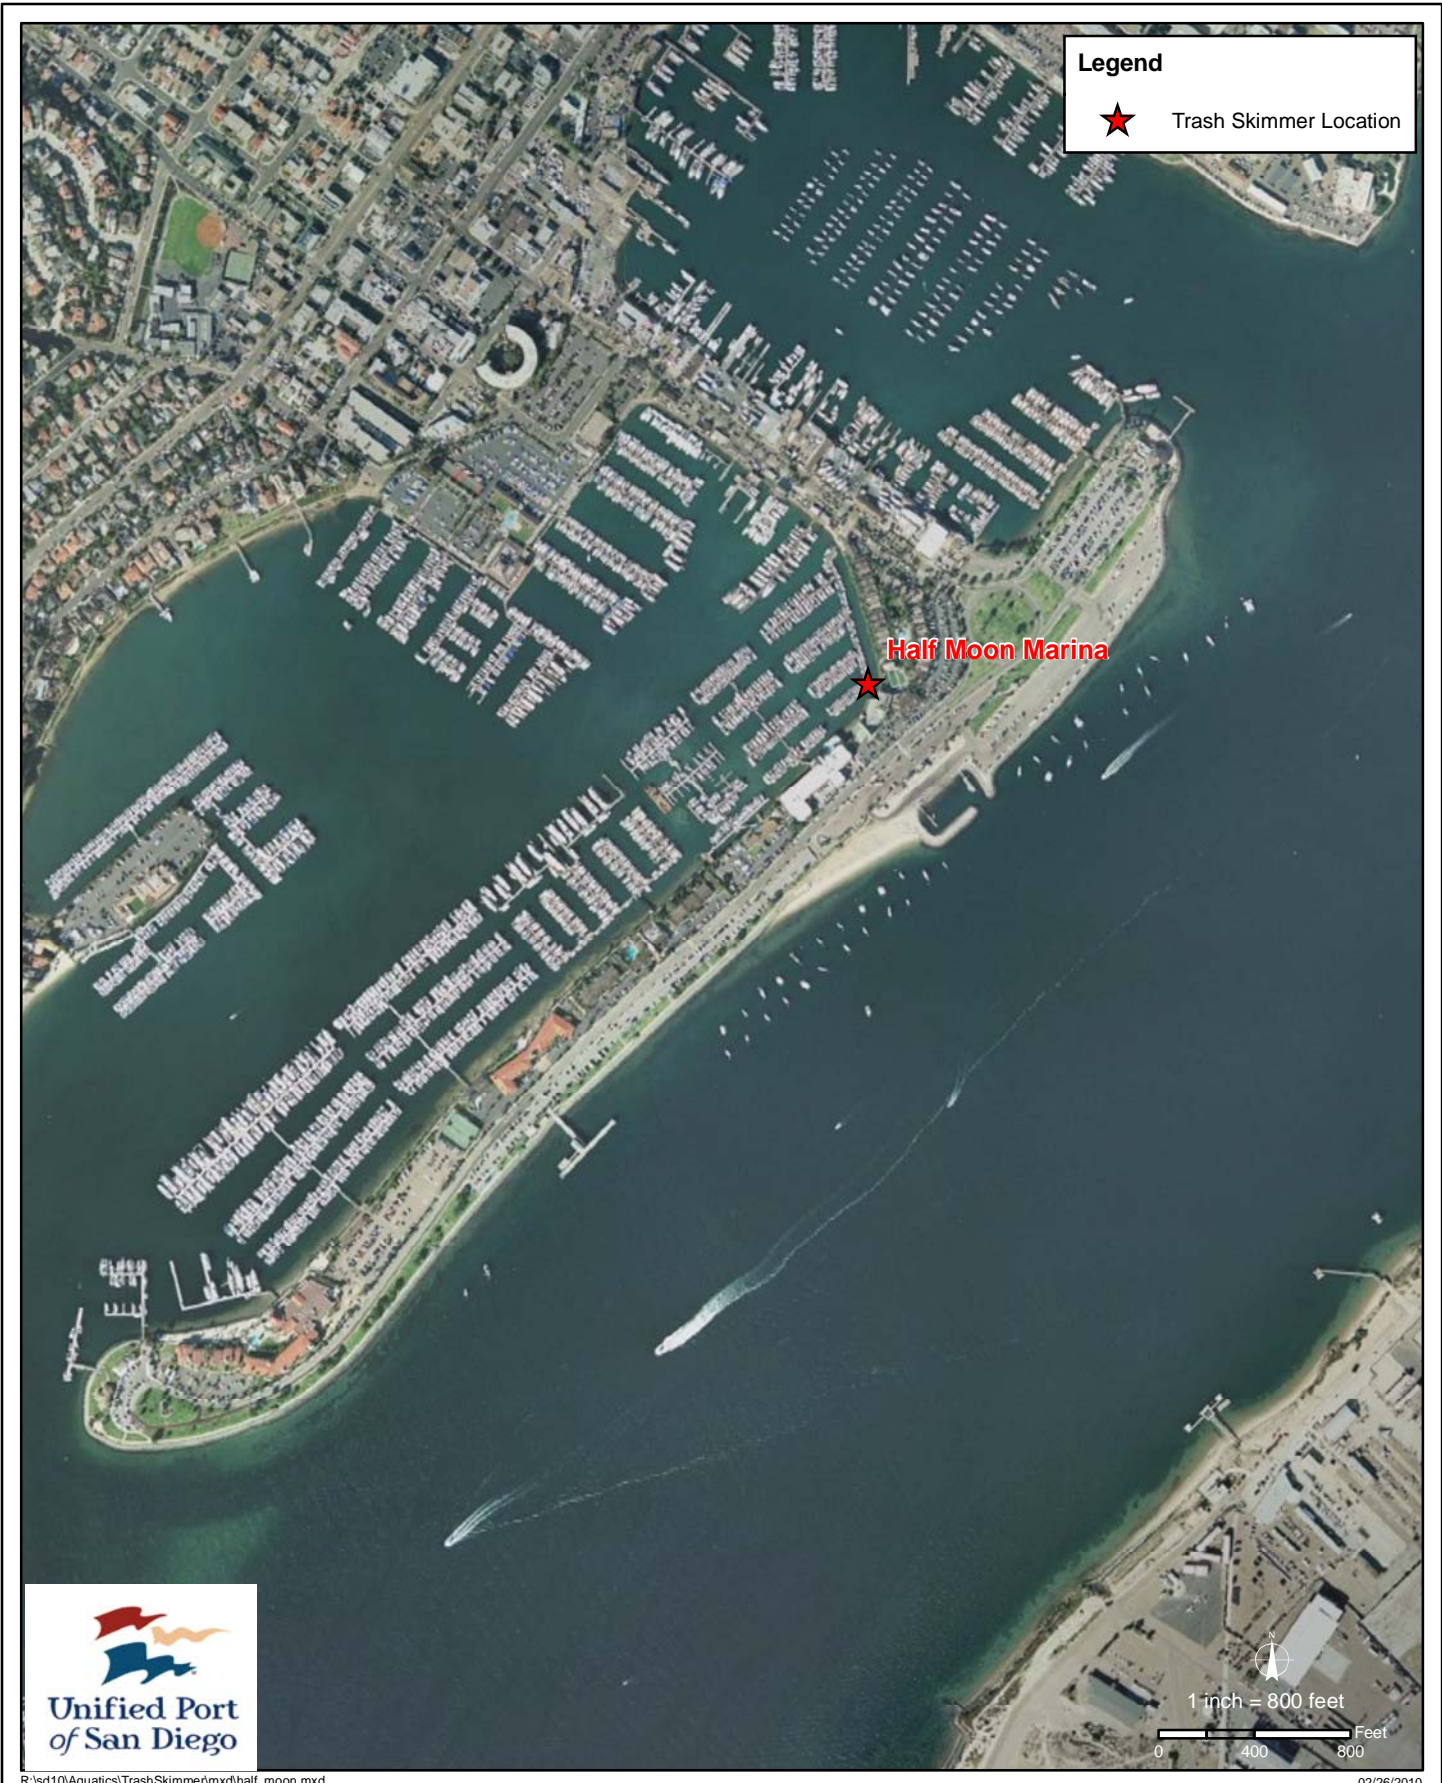
FIGURE
4

The skimmer at Half Moon Marina is located at the eastern end of the Shelter Island Basin (Figure 4). The location is immediately adjacent to an open concert venue at Humphrey's By the Bay (Humphrey's), an inner harbor area with limited flushing that chronically accumulates debris and often has a visible surface sheen. The Humphrey's concert venue overlooks the marina, providing an optimum location for signage recognizing the Port's environmental stewardship. Between July and August 2010, the Half Moon Marina skimmer collected a total of approximately 810 gallons of trash; 390 gallons in July and 420 gallons in August (Table 3). The dominate types of debris collected included leaves, plastic debris, wood, cigarette butts, and

Half Moon Marina
Trash Skimmer Location

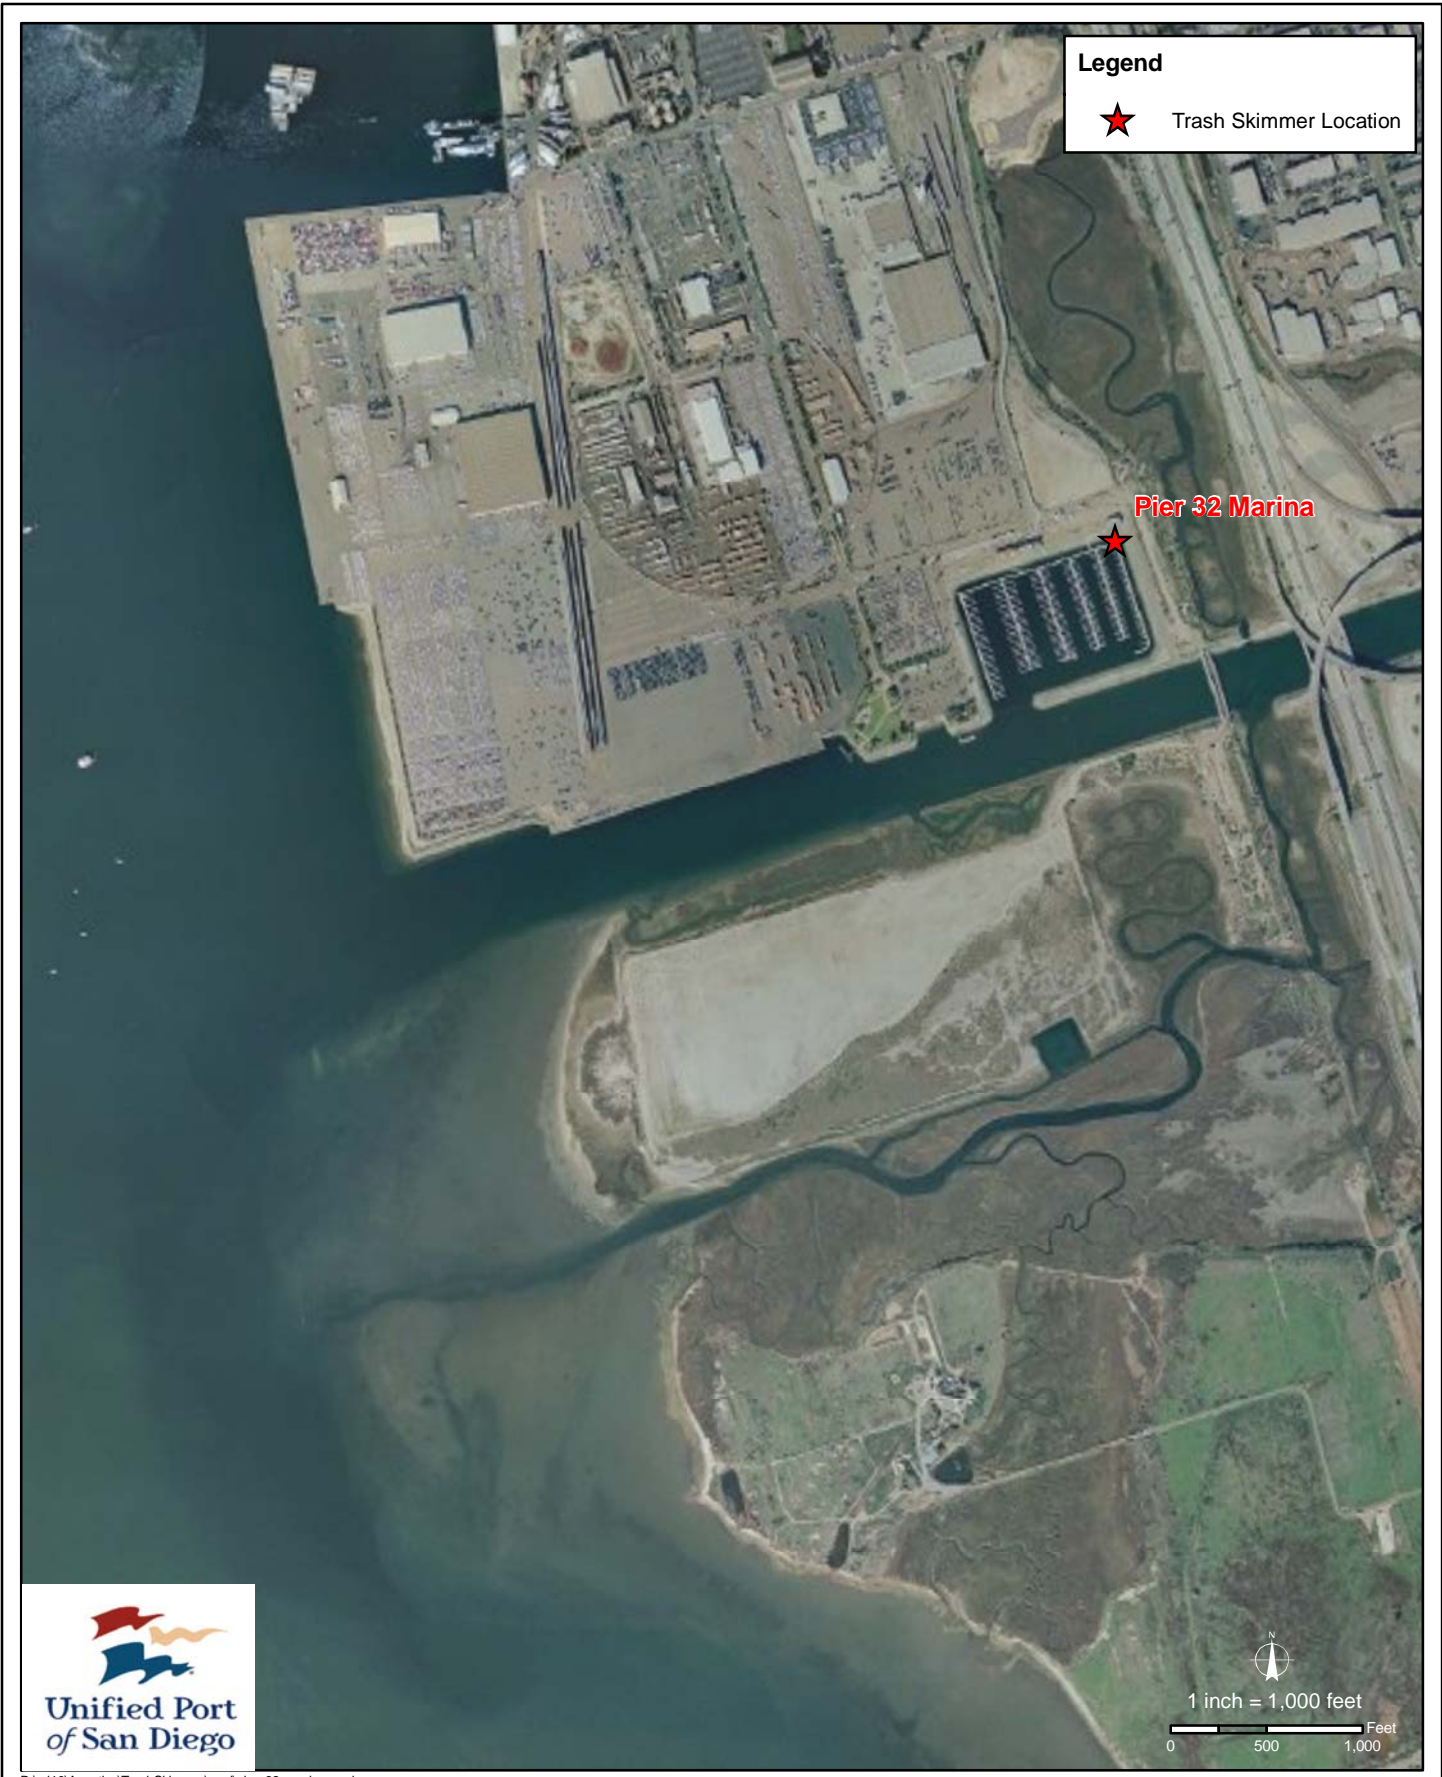
**FIGURE
5**

The skimmer at the Pier 32 Marina, like the others, is also located in an area that receives limited tidal flushing (Figure 5). Its location in the northeast corner of the marina is protected from predominant winds by a rip-rap breakwater that extends approximately 20 feet above the water surface at mean low tide. The skimmer is highly visible and can be viewed from the landside walkway above the rip-rap. Nearby is the marina's BBQ/picnic area as well as an open public area known as "The Beach".

**Pier 32 Marina
Trash Skimmer Location**
